# Burned Area Emergency Response

## Spring Creek Fire

Pike - San Isabel National Forest and Royal Gorge Field Office

July 15-23, 2018

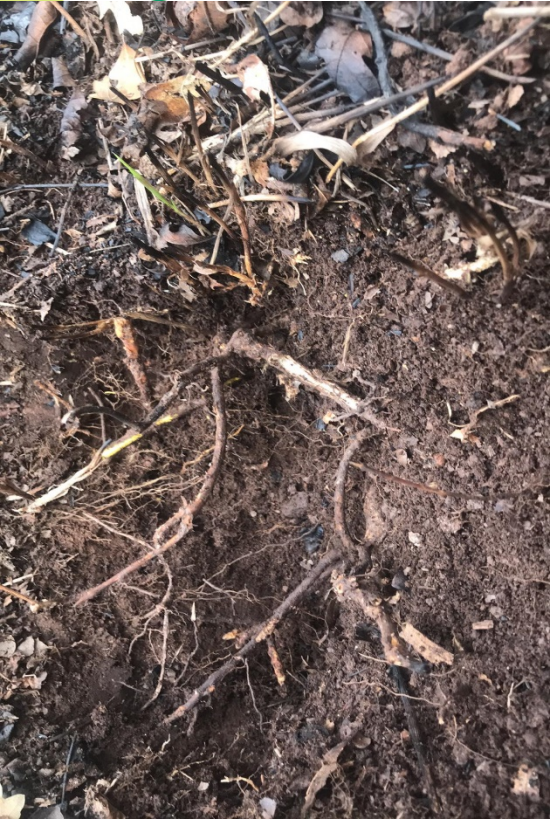
## Unburned / Very Low:

Slight to no duff scorching, no below ground effects

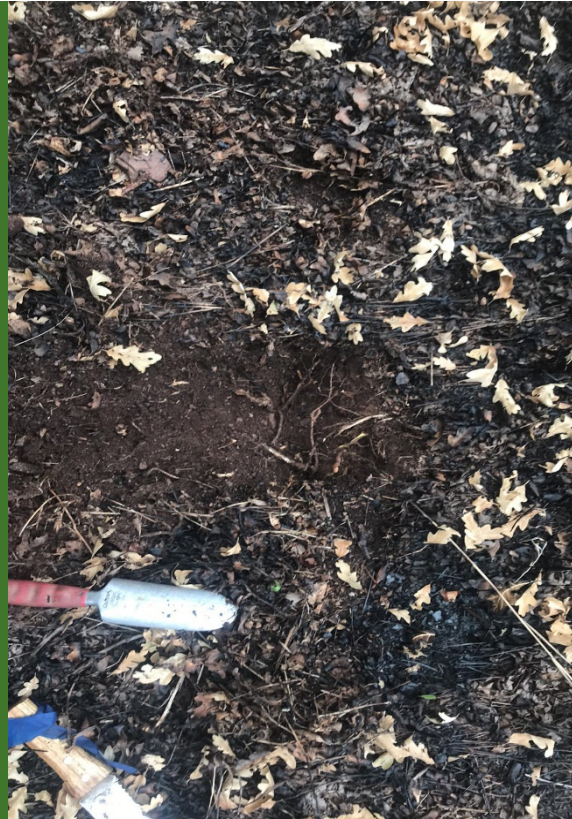
## Low:

Soil cover/duff reduced, Increased surface water repellency, minimal mineral soil effects

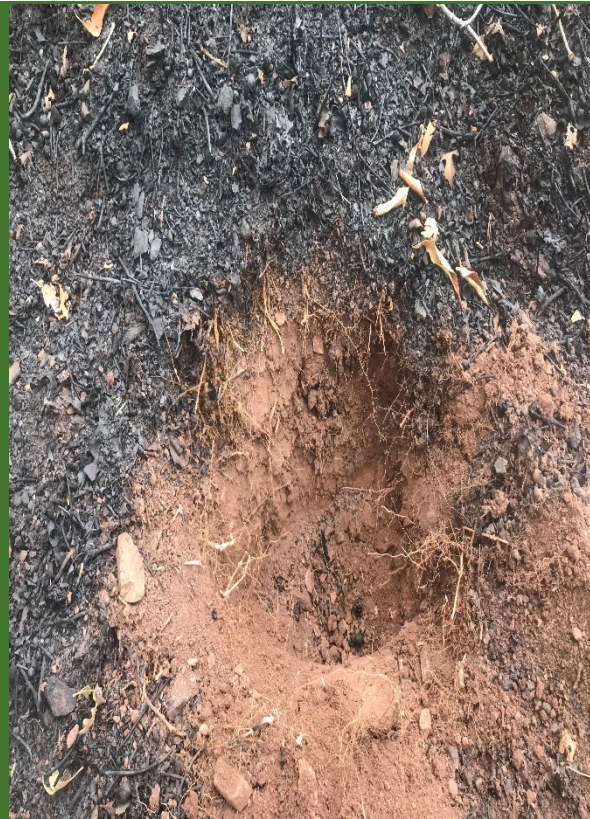
## Moderate

Duff mostly altered reduce benefit, stronger water repellency, mortality of surface roots, soil structure weakening

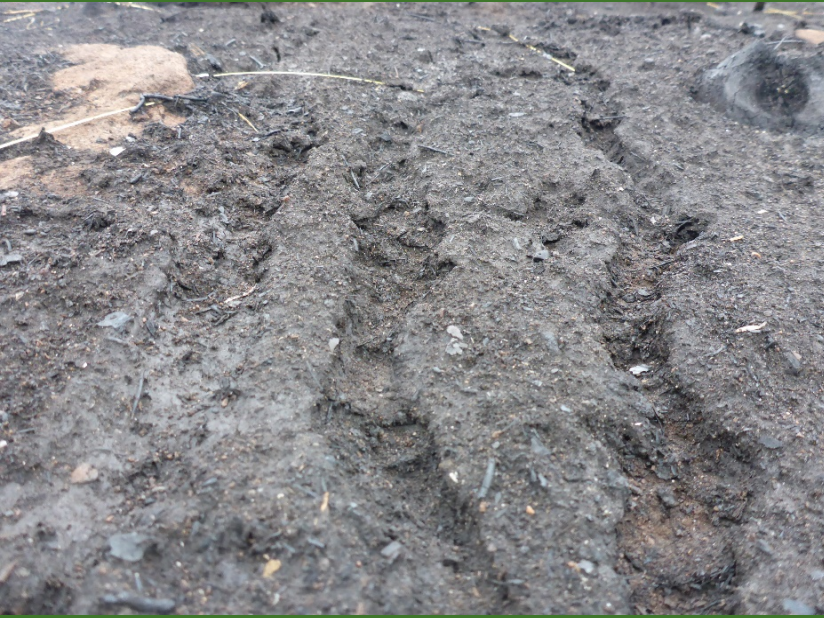
Rill erosion prevalent where thunderstorms occurred. Rill depth determined by depth of live roots and water repellent layer.

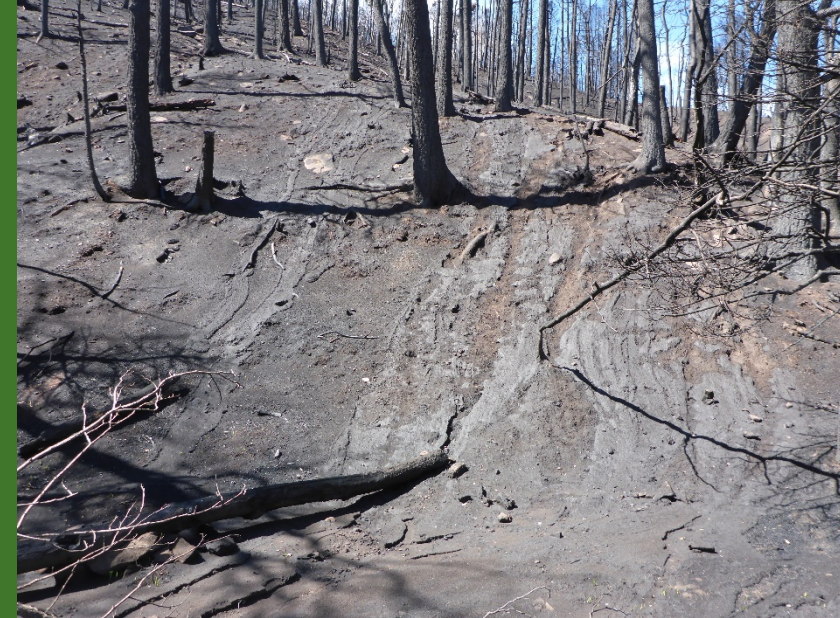
Severe sheet erosion at Indian Creek. Occurs when capacity of rills are exceeded and flow spreads out to sheet flow.

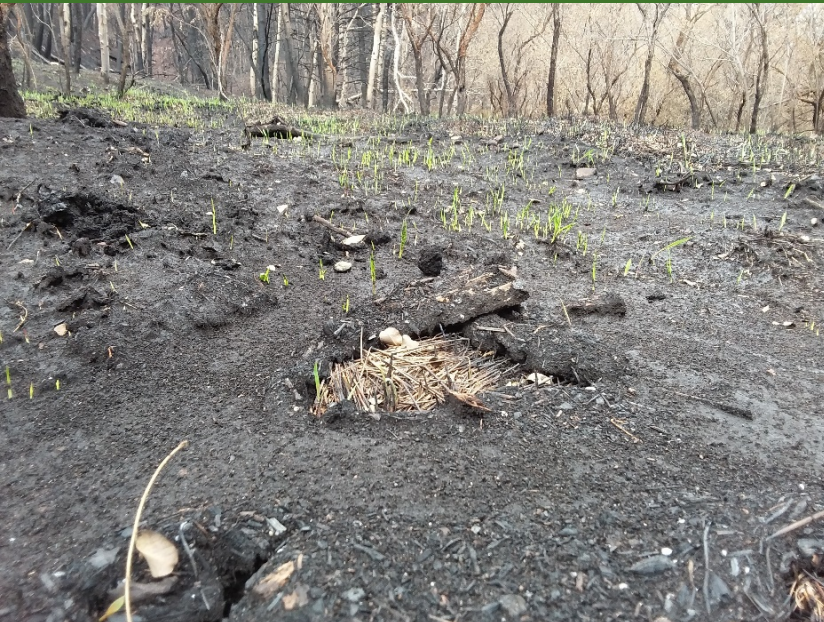
Transport of thick sediment deposits to Indian Creek. Re-establishment of vegetation ameliorates sediment transport.

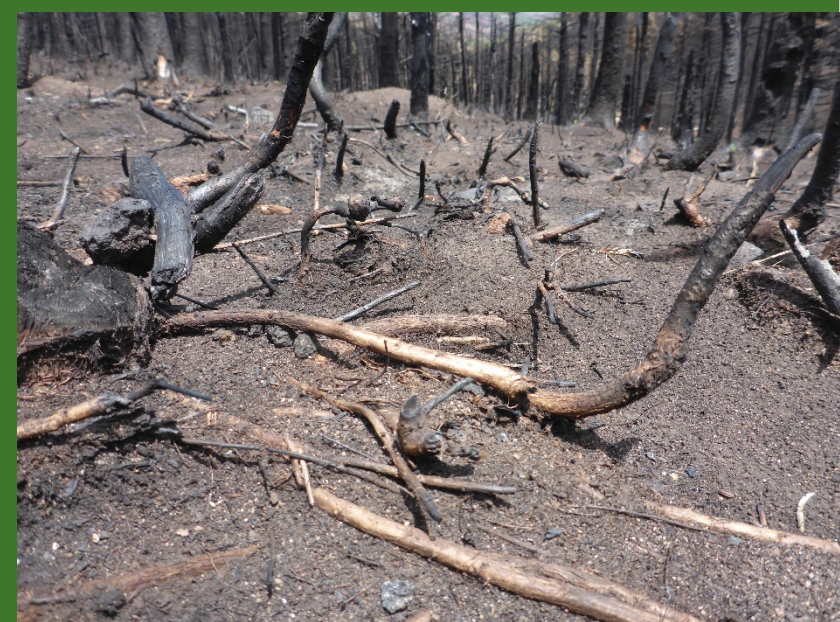
Extreme sheet erosion at Silver Mountain. Note unburned roots segments that were below ground before storms.

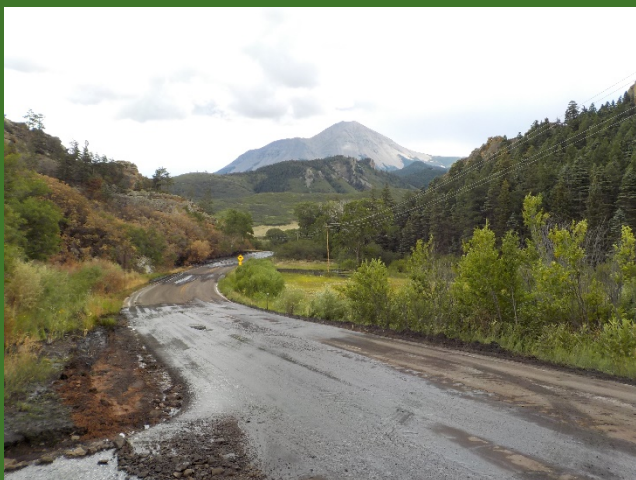
0.7 inches of rain produced these overtopping flows of CO Hwy 12

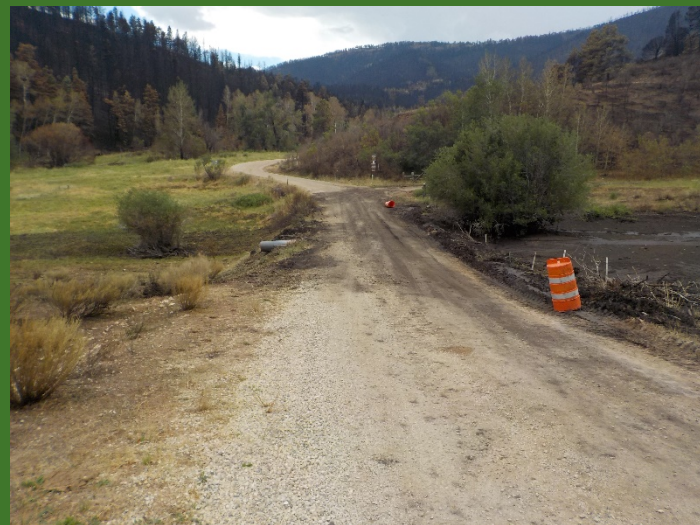
South Abeyta Creek overtopped road crossing

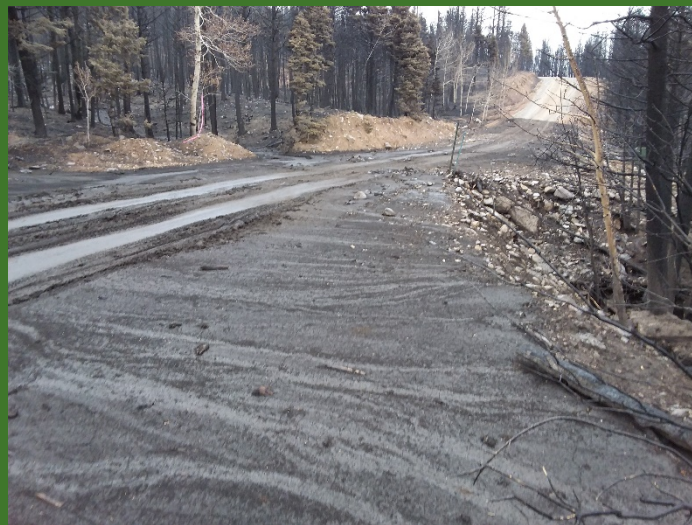
Road in Paradise Acres at high risk for washouts and debris flows

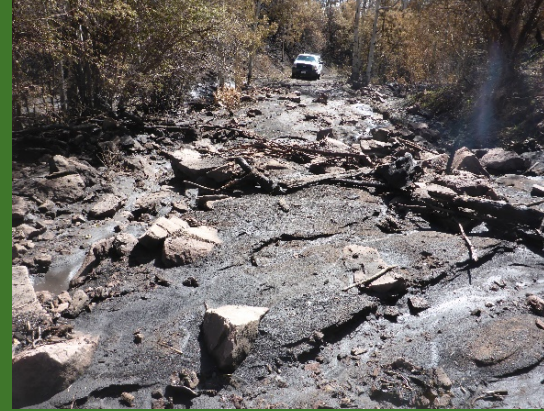
*Private road washed out by debris flow*

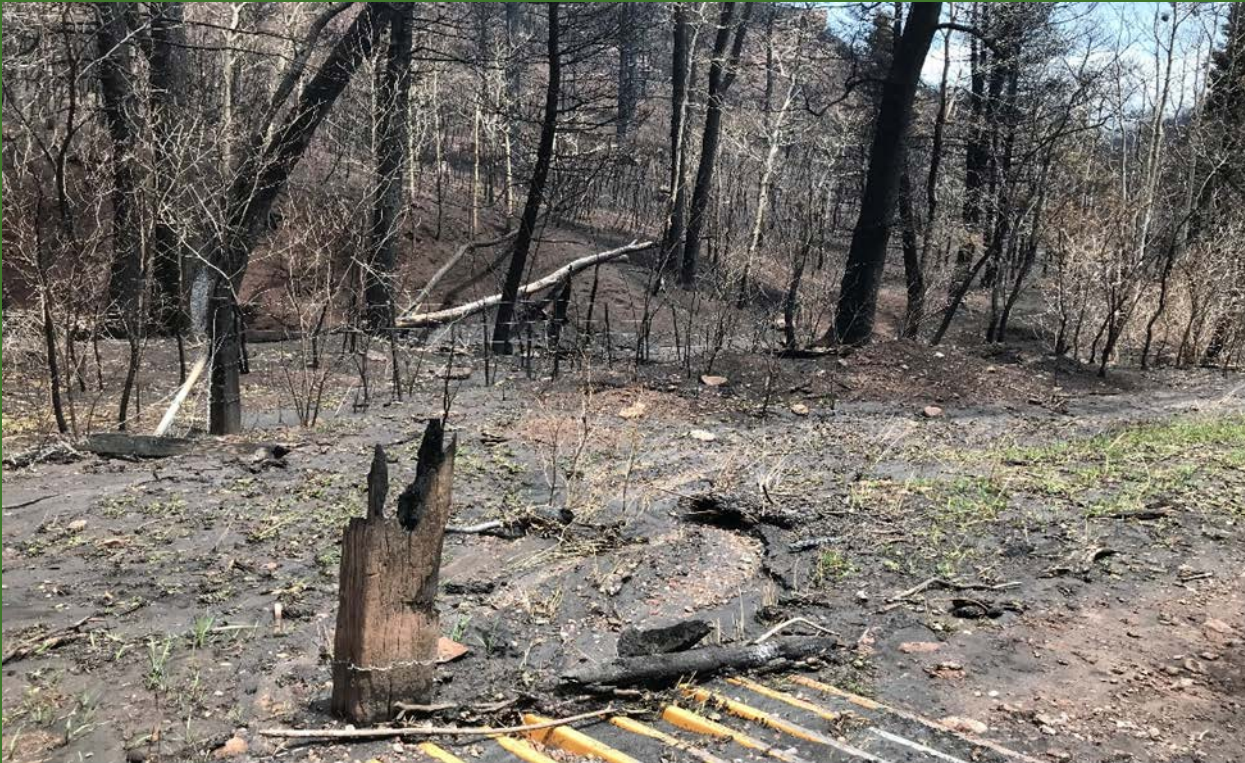
Burned Fence Indian Creek (Photo: Eduardo Duran, BLM)

- Construct new fence along surveyed boundaries.
- Fencing allows for proper rest of rangeland vegetation for recovery in areas of high to moderate soil burn severity (SBS) and maintenance in areas of low SBS or unburned.
- Allotments in high to moderate SBS have a high potential for erosion and slow recovery due to low precipitation levels, slope, soil and vegetation type.
- Boundary fence allows proper management, rest and recover of rangeland vegetation.

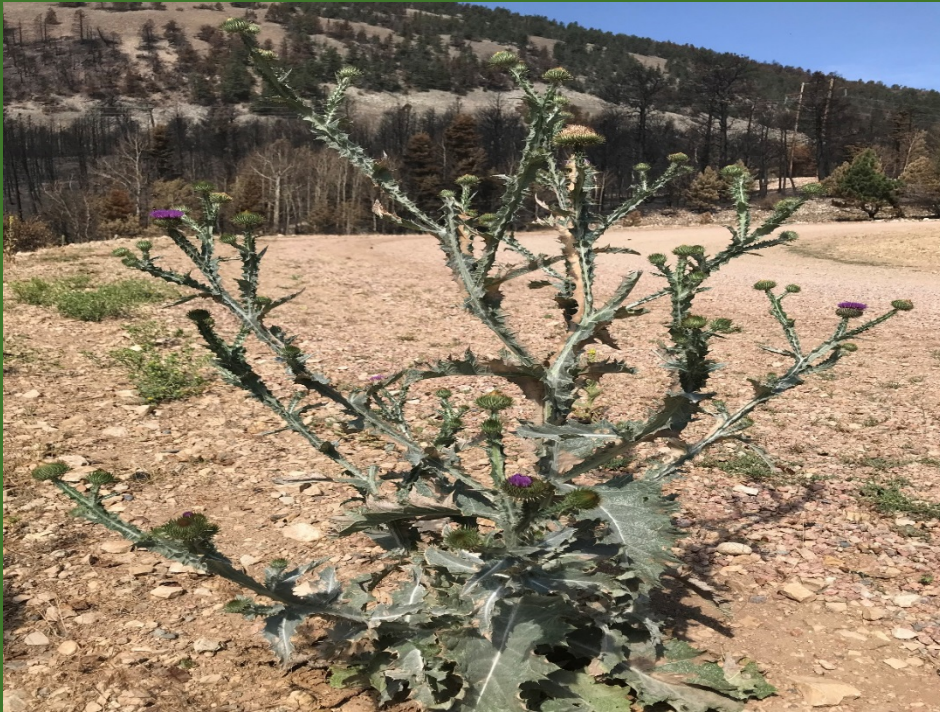
Scotch Thistle-Sheep Mtn. (Photo: 2018 Eduardo Duran, BLM)

- Early detection and rapid response (EDRR) needed along dozer lines, roads/trails and in High to Moderate SBS areas, especially those located in Cuchara Roadless Areas.
- Treat known and newly found weed infestation while conducting early detection surveys.
- Decreased noxious weed establishment/dispersal
- Reestablish desirable plants and a healthy plant community

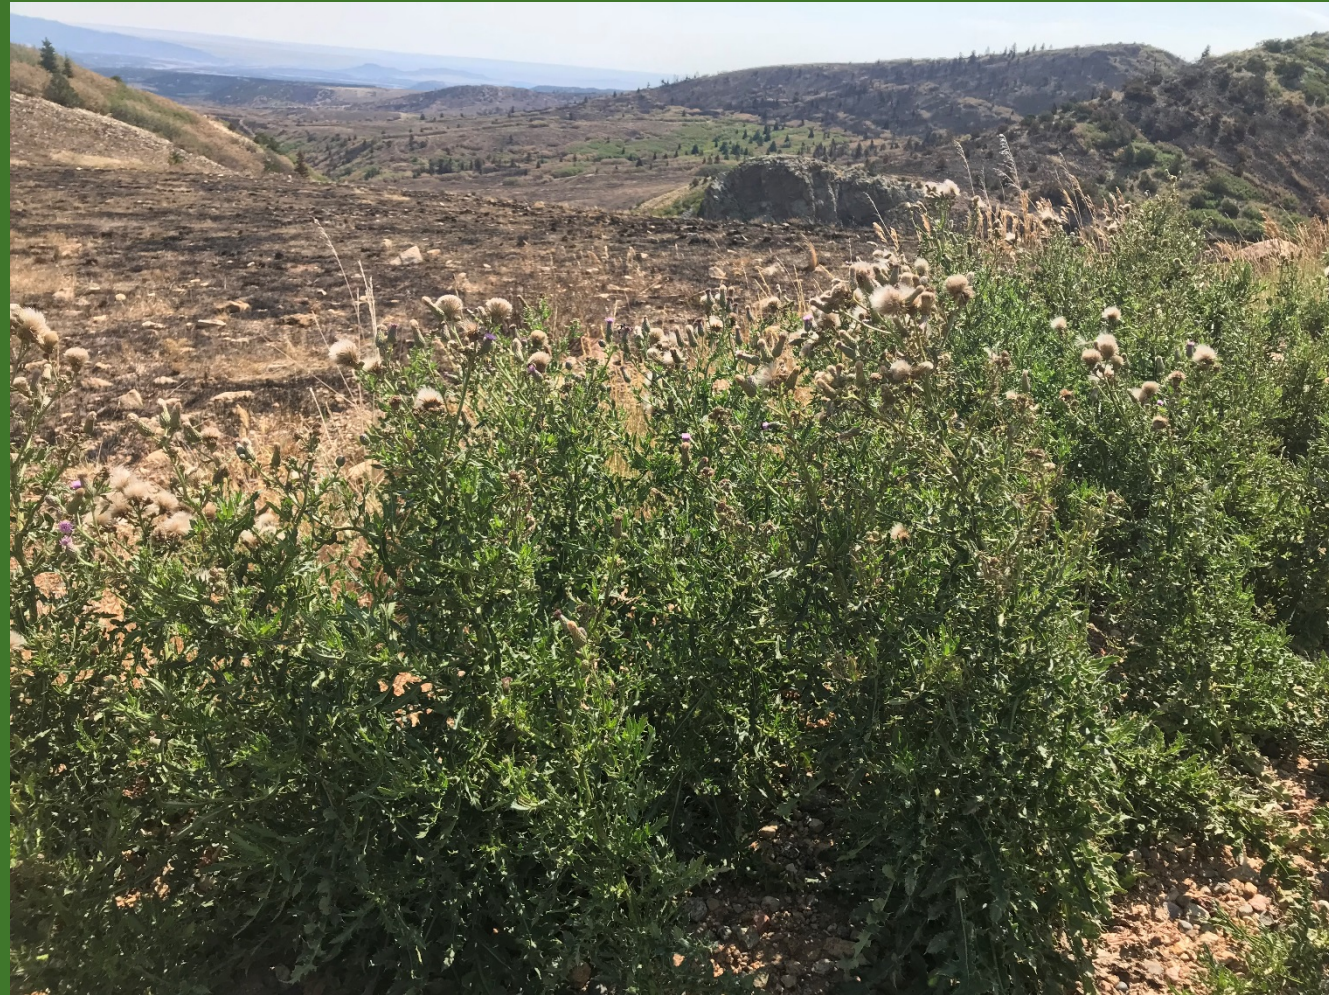
Post Fire Canada thistle Rough Mtn. (Photo: 2018 Eduardo Duran, BLM)

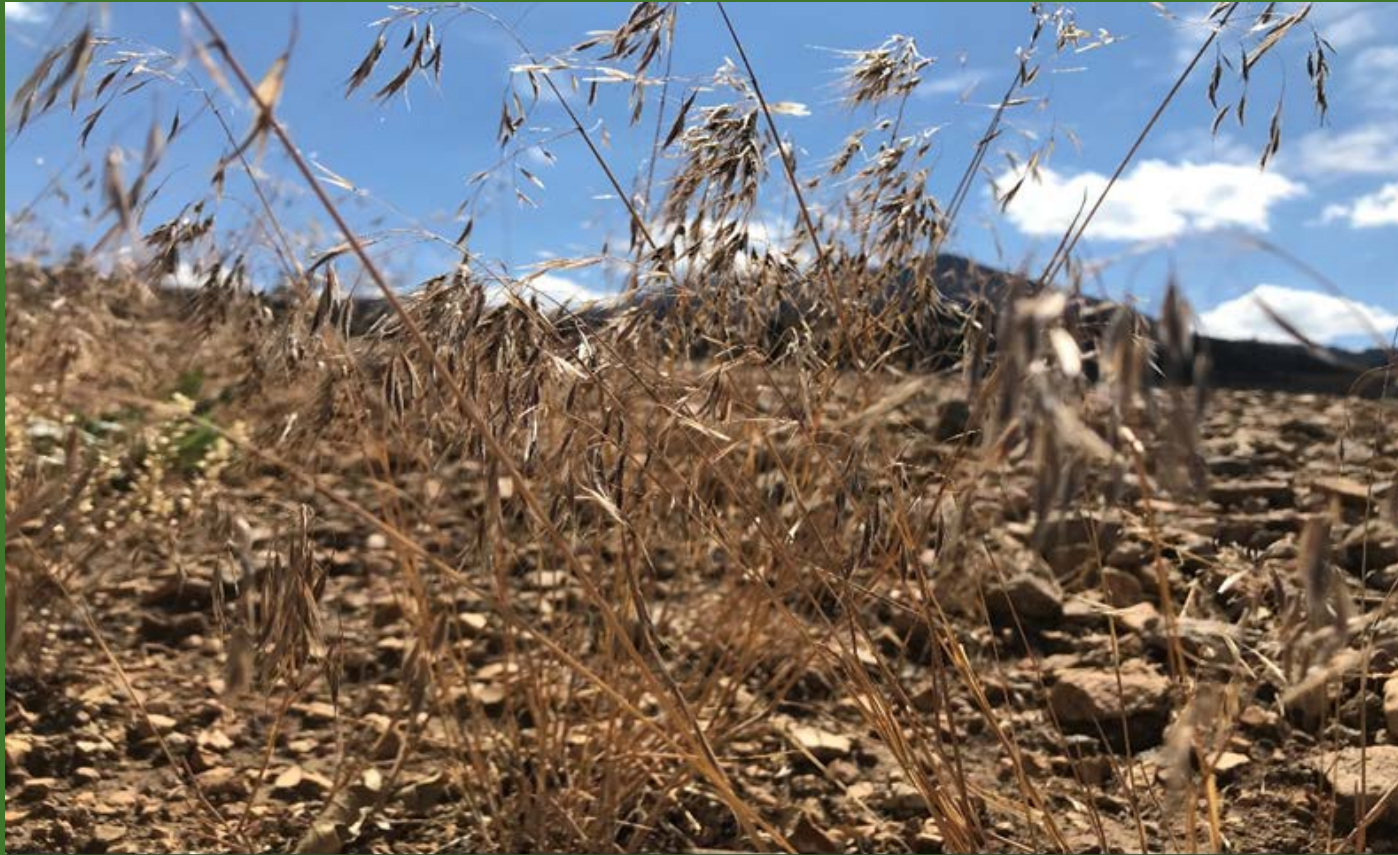
Downy brome Silver Mtn (Photo: Eduardo Duran , BLM)
