# Burned Area Emergency Response

## Spring Creek Fire

Pike - San Isabel National Forest and Royal Gorge Field Office

July 15-23, 2018

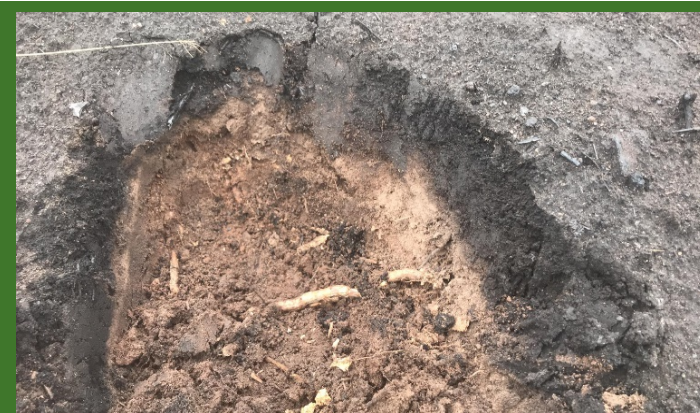
## High:

Complete combustion of soil cover, soil structure destroyed, deeper root mortality, deeper and stronger water repellency. Top photo before rain compaction and erosion lower photo after rain.

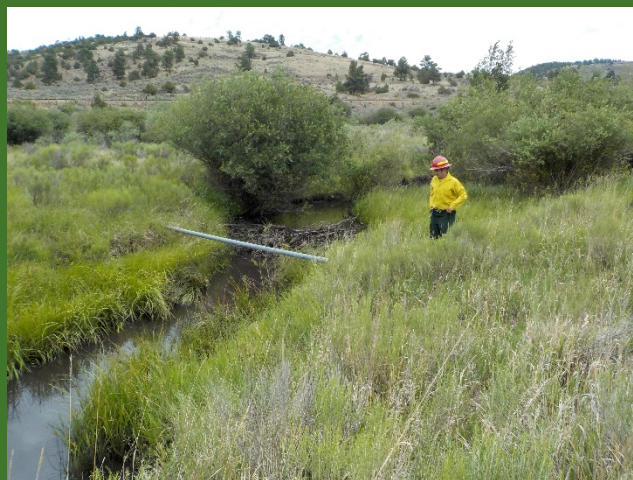
Buried utility line exposed at crossing of Wagon Creek within Forbes Park

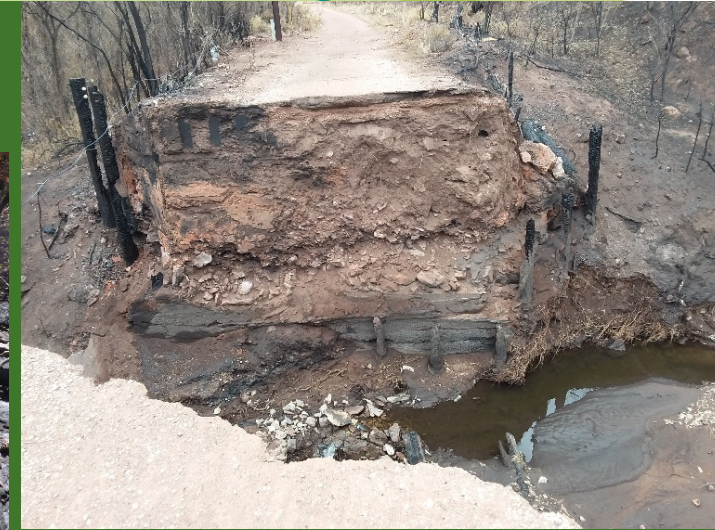
*South Abeyta Creek – private or utility access road*

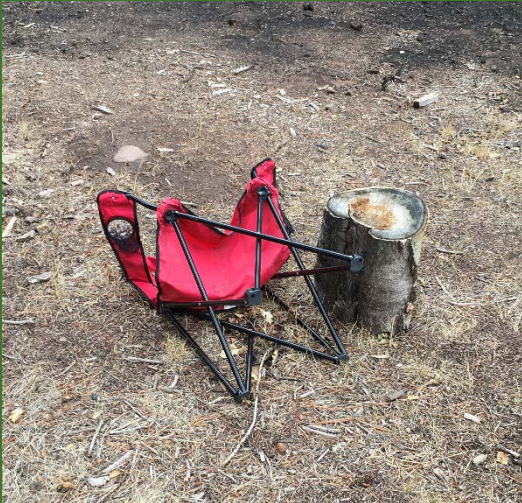
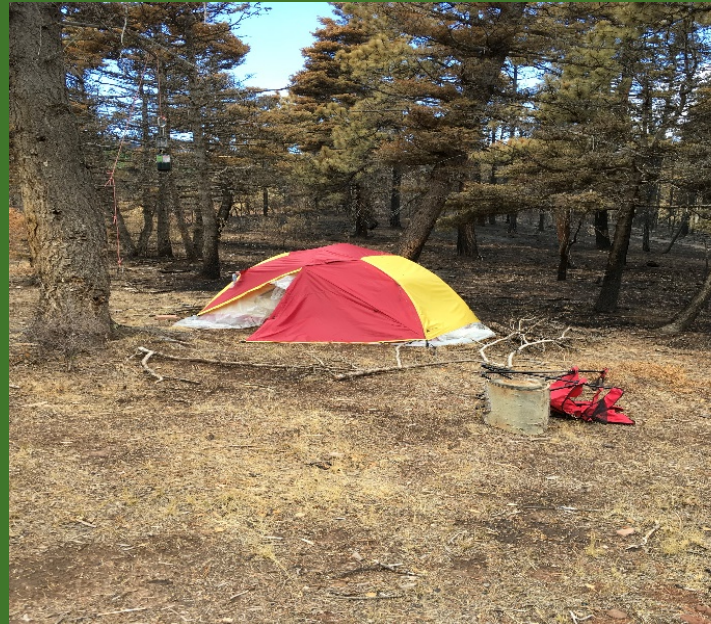
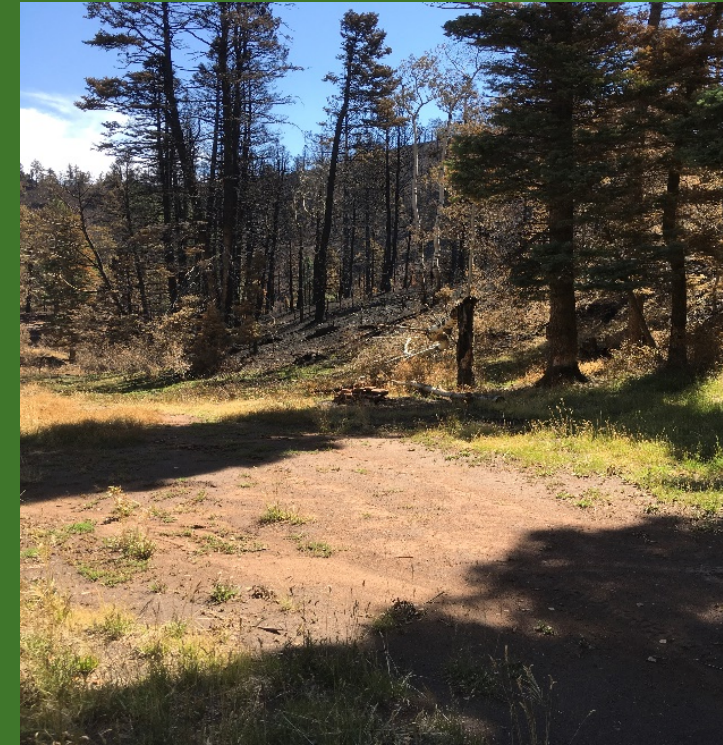
Hazard Tree risk

Temporary Closure and Informational signing

- Forest Boundary Warning Signs
- Signs at popular camp sites

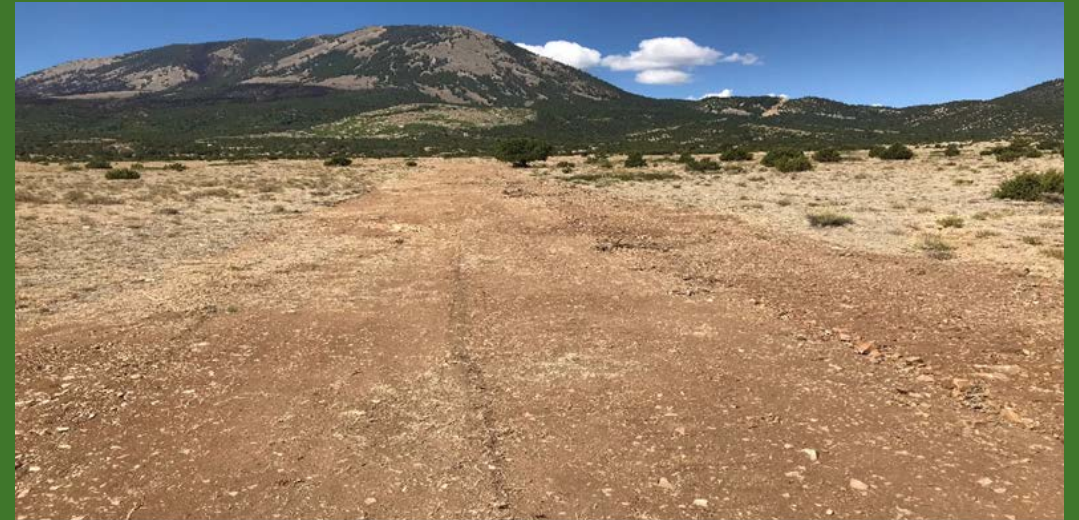
- On BLM lands, 5.76 miles of dozer line & on FS lands 8.99 miles dozer lines intersect with known noxious weed infestations.
- Invasive plants were observed & have been inventoried along access roads and in areas where suppression activities occurred.

Completed Dozer Line on BLM, (Photo: 2018 Eduardo Duran, BLM)

- Early detection and rapid response (EDRR) needed along dozer lines, roads/trails and in High to Moderate SBS areas, especially those located in Cuchara Roadless Areas.
- Treat known and newly found weed infestation while conducting early detection surveys.
- Decreased noxious weed establishment/dispersal
- Reestablish desirable plants and a healthy plant community

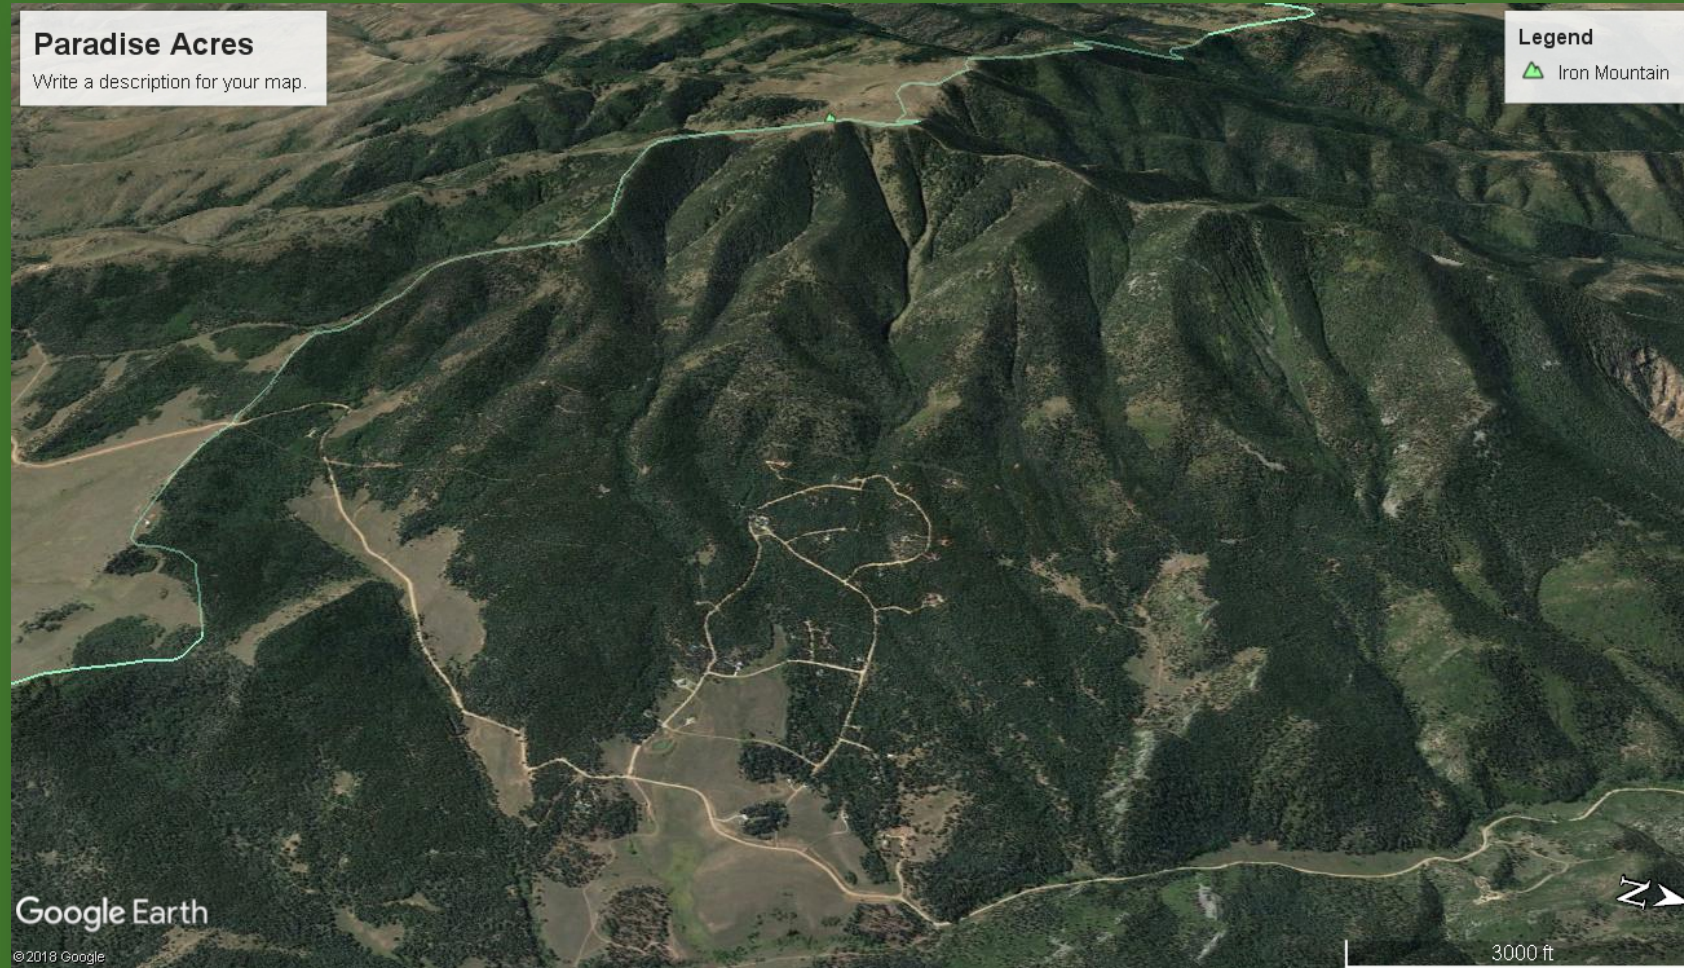
Paradise Acres (evulsion zone/fan) & Pass Creek SR 572 (floodplain)

- Paradise Acres (evulsion zone/fan)
- Sulfur Springs (floodplain)
- Pass Creek – SR 572 (road on stream terrace)
- Vories Creek – Hwy 12 (stream terrace/fan)
